# Manhole Inspection Summary

Manhole # S35YY\_036MH

Insp Date: **12/22/06 11:50 AM**

**Location** Address: **100 32ND ST**

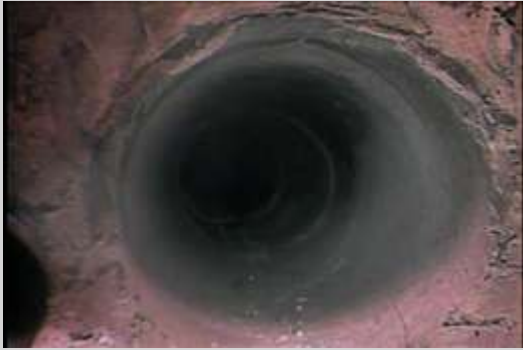
### 15 in. Circular Gravity Sewer

Pipe Material: **Concrete** ☐ Pipe Lined

Invert Depth: **6.03** (ft.) Flow Characteristics: **None**

Infiltration: **None**

Pipe Seal Cond: **Unknown**

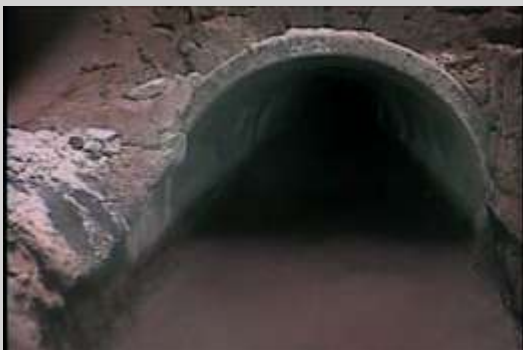
### 18 in. Circular Gravity Sewer

Pipe Material: **Clay** ☐ Pipe Lined

Infiltration: **None**
